IWMI's First Monitoring Visit to SIP Implementation Sites in Bangladesh

From 21st February to 1st March 2022 a two-member team from IWMI, SoLAR – Bangladesh visited 10 sites, five each in Northwest and Southwest Bangladesh. These visits were to monitor the progress of the implementation work carried out by NGO Forum, and to measure the flow rates of the SIP vis-à-vis the diesel pumps.

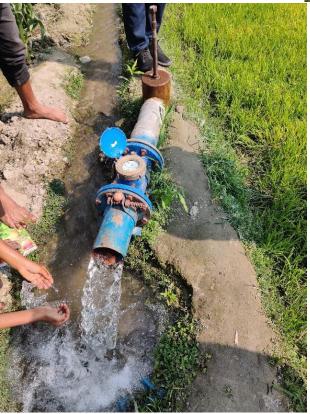
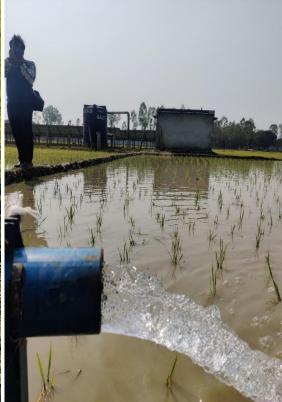
In all the sites, the team selected 3 outlets for monitoring that had flow meters installed, and the concerned SIP operator was trained to maintain an irrigation logbook. Individual diesel farmers selected in nearby areas and were also provided with logbooks to maintain.

- In 4 out of 5 sites SIP operators were found to maintain the logbook, while in 2 out of the 3 sites with piezometers, operators were found to take correct reading of flow rates.
- Quality of data on flow rates could be affected if SIP operators do not monitor outlets at full flow as could be variation in the flow rates across outlets when these are not operating at full flow.
- The team had selected 8-9 diesel farmers for monitoring and out of them they visited 2 farmers. Logbooks for those were maintained and the team measured the flow at their pumps. For most, flow rates were ~ 5 l/s except for one site in Dolua Rangpur where pumps have higher depth and flow rates were ~ 10 l/s.

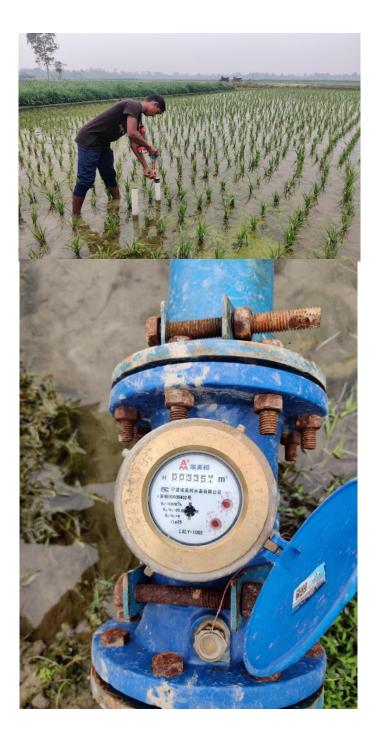
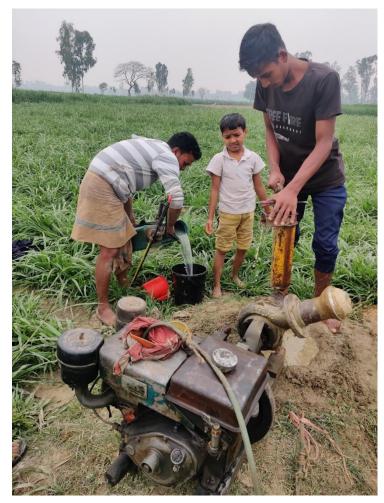
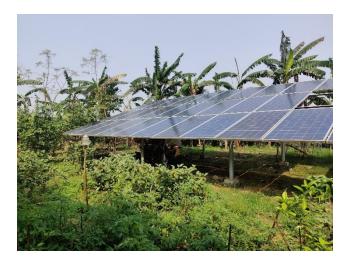
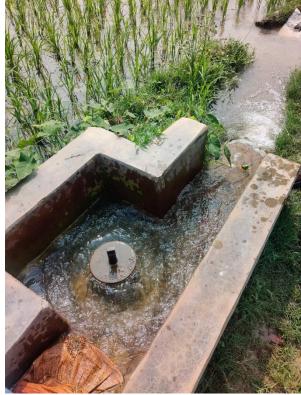
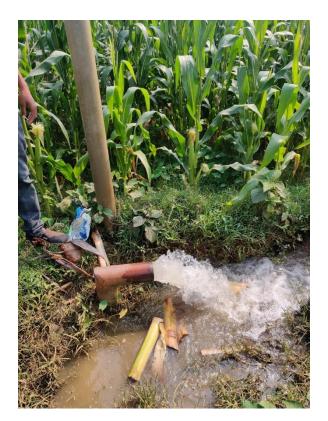
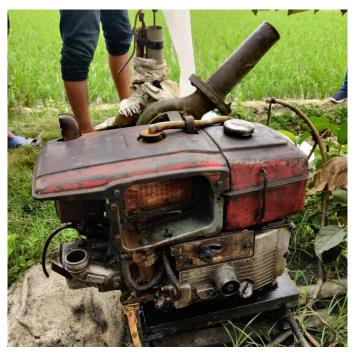
- Selection of monitoring outlets was similar to that in the Northwest
- As the sites were not conducive to installing flow meters, monitoring was based on the logbooks maintained by SIP operators and outflow rate tests carried out by the team.

- The team did not monitor individual diesel farmers here but surveyed diesel water sellers to water use in SIP and diesel command
- areas
- Flow rates at sites where outlets were piped and above ground, were found to be much higher at 20-25 l/s, than in the Northwest.
- Flow rates were found to be high in diesel pumps also (~ 15 l/s), especially with high capacity pumps.
- Distance between sites can act as a deterrent for efficient monitoring since it may constrain the local personnel from visiting two to three sites simultaneously, and carry out overall monitoring more frequently.
